# Manhole Inspection Summary

Manhole # S07GG2028MH

Insp Date: **9/9/08 11:20 AM**

**Location** Address: **2701 HANSON**

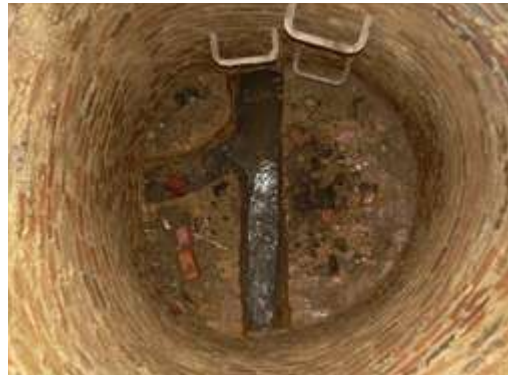
Top View

**Bench** ☒ Exists Material: **Brick** ☐ Parged ☒ **Debris** (not Condition related)  
Condition: ☒ Sound ☐ Cracked ☐ Root Intrusion ☐ Deteriorated ☐ Leaks ☐ Debris

**Channel** Material: **Brick** ☐ Parged ☒ **Debris** (not Condition related)  
Channel Exposure: **Fully Open** Junc Dist: **0** nearest .5 ft. Azimuth:  
Condition: ☐ Sound ☐ Cracked ☐ Root Intrusion ☒ **Deteriorated** ☐ Leaks ☐ Debris

**Surcharge** ☒ **Evidence Of Surcharge** Depth: **3** (ft.) ☐ Active Surcharge Present

Evidence of surcharge - Bench debris.  
Channel debris.

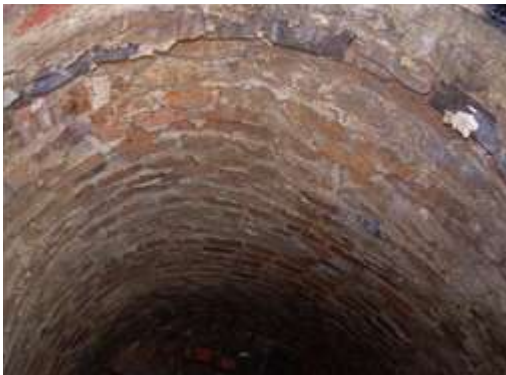
Defect

**Chimney / Frame Adjustment** ☒ Exists Material: **Brick** ☐ Parged Height: **6** (in.)  
Condition: ☒ Sound ☐ Cracked ☐ Root Intrusion ☐ Loose Brick ☐ Deteriorated  
Infiltration: ☐ None ☒ **Joint** ☐ Cracks ☒ **Mortar** ☐ Roots ☐ Wall

**Corbel** Material: **Brick** ☐ Parged Type: **Flat top**  
Condition: ☒ Sound ☐ Cracked ☐ Root Intrusion ☐ Loose Brick ☐ Deteriorated  
Infiltration: ☐ None ☐ Joint ☐ Cracks ☐ Mortar ☐ Roots ☒ **Wall**

**Barrel** Material: **Brick** ☐ Parged  
Shape: **Circular** Diameter: **42** (in.) Length: (in.)  
Condition: ☒ Sound ☐ Cracked ☐ Root Intrusion ☐ Loose Brick ☐ Deteriorated  
Infiltration: ☐ None ☐ Joint ☐ Cracks ☐ Mortar ☐ Roots ☒ **Wall**

Adjustment, Corbel and Barrel infiltration.

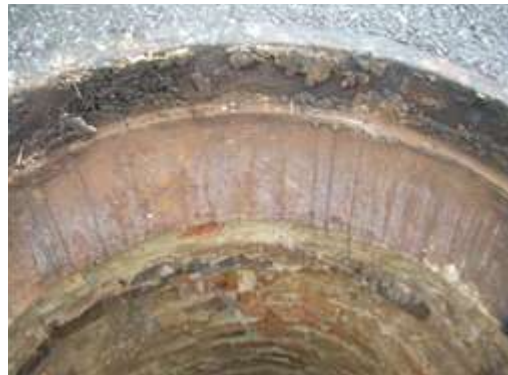
Defect

Adjustment infiltration.

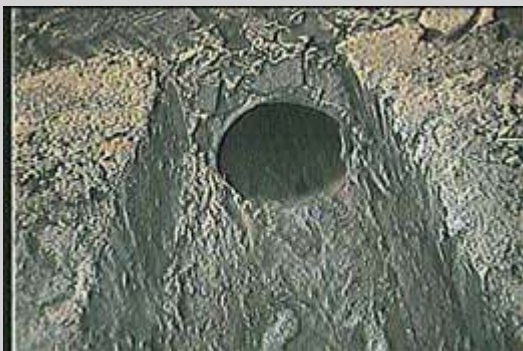
### 8 in. Circular Gravity Sewer Pipe In @ 6 O'Clock

Channel deterioration.

Infiltration: **Evidence** Pipe Seal Cond: **Cracked**

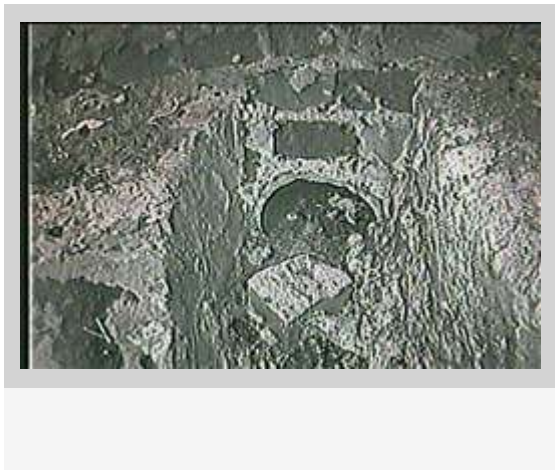
8 in. Circular Gravity Sewer  
Pipe In @ 9 O'Clock

Deposits: ☐ None ☒ **Mud** ☐ Sludge ☒ **Debris** ☐ Grease

Silt Depth: **3** (in.) Deposits Extent: **Medium**
